Manhole Inspection Summary

Manhole # S33UU1001MH

Location Address: **6 GOODALE PL** Cross Street: **PADDINGTON RD**

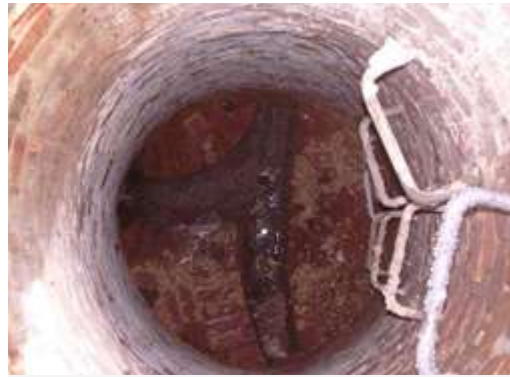
Top View

Evidence of surcharge - Bench debris.
Channel debris.

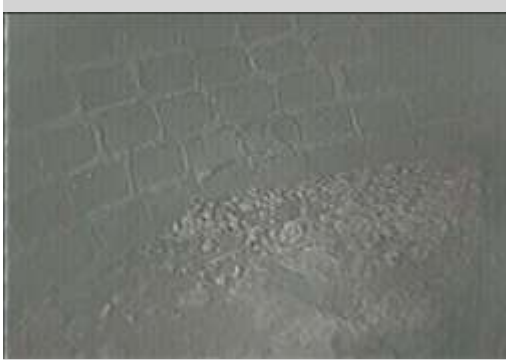
Defect

Barrel Material: **Brick** ☐ Parged
Shape: **Circular** Diameter: **42** (in.) Length: (in.)
Condition: ☐ Sound ☒ **Cracked** ☐ Root Intrusion ☐ Loose Brick ☒ **Deteriorated**
Infiltration: ☐ None ☐ Joint ☒ **Cracks** ☒ **Mortar** ☐ Roots ☐ Wall

Barrel deterioration and infiltration.

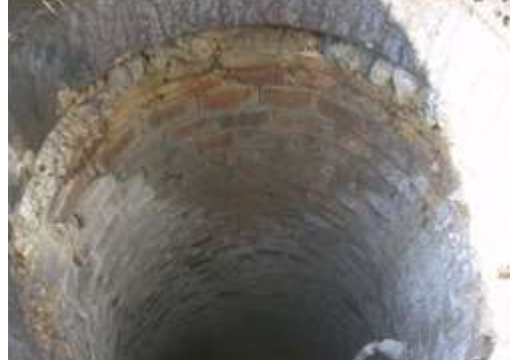
Defect

Frame leaks. Adjustment deterioration,
loose brick, cracks and infiltration. Corbel
cracks and infiltration - other side.

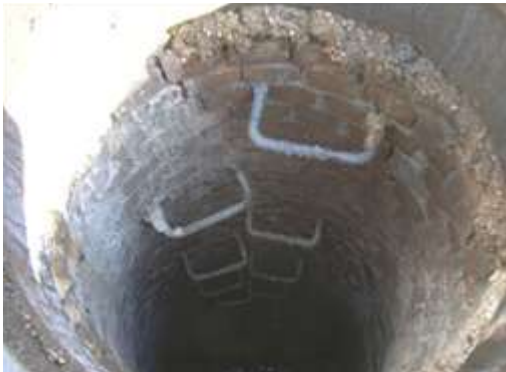
Defect

Frame Offset: **0** (in.) Condition: ☐ Sound ☐ Cracked ☒ **Leaks**

Chimney / Frame Adjustment ☒ Exists Material: **Brick** ☐ Parged Height: **24** (in.)
Condition: ☐ Sound ☒ **Cracked** ☐ Root Intrusion ☒ **Loose Brick** ☒ **Deteriorated**
Infiltration: ☐ None ☒ **Joint** ☒ **Cracks** ☒ **Mortar** ☐ Roots ☐ Wall

Corbel Material: **Brick** ☐ Parged Type: **Concentric/Eccentric**
Condition: ☐ Sound ☒ **Cracked** ☐ Root Intrusion ☐ Loose Brick ☐ Deteriorated
Infiltration: ☐ None ☐ Joint ☒ **Cracks** ☐ Mortar ☐ Roots ☒ **Wall**

Frame leaks. Adjustment deterioration,
loose brick, cracks and infiltration. Corbel
cracks and infiltration.

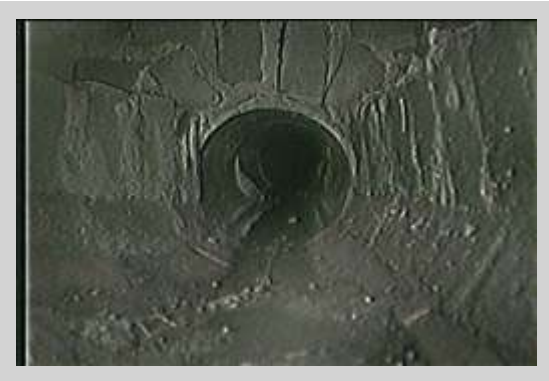
8 in. Circular Gravity Sewer Pipe Out @ 12 O'Clock

Infiltration: **None** Pipe Seal Cond: **Cracked**

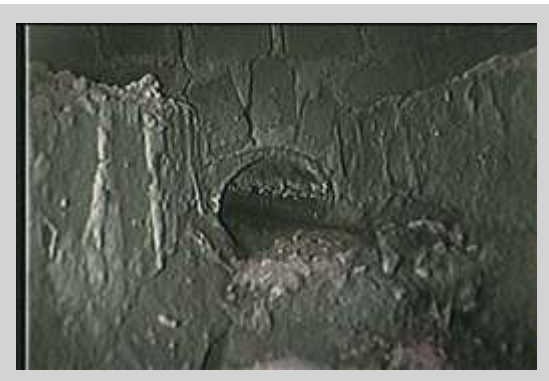
6 in. Circular Gravity Sewer Pipe In @ 5 O'Clock

Channel deterioration and debris.

Deposits: ☐ None ☒ **Mud** ☐ Sludge ☒ **Debris** ☒ **Grease**

Silt Depth: **0.5** (in.) Deposits Extent: **Light**

Infiltration: **Evidence** Pipe Seal Cond: **Cracked**

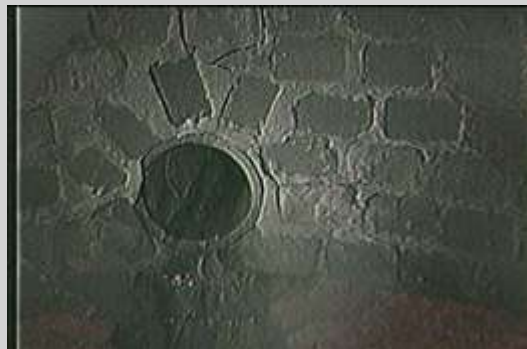
6 in. Circular Gravity Sewer

Barrel cracks.

Pipe Seal Cond: **Cracked**
